Manhole Inspection Summary

Manhole # S19II_027MH

Insp Date: **3/12/09 1:24 PM**

Location Address: **1821 NORTH-WESTWOOD**

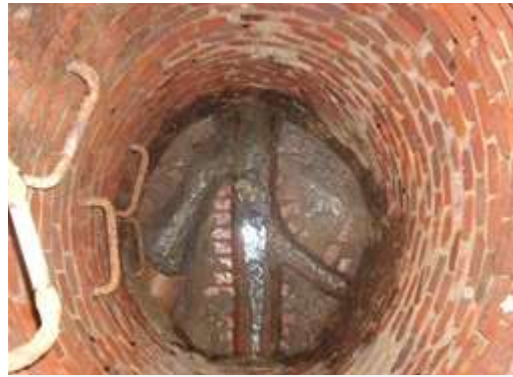
Top View

Comments **TOOK NEW TOP VIEW PHOTO AS REQUESTED - REWORK COMPLETE 3-12-09**

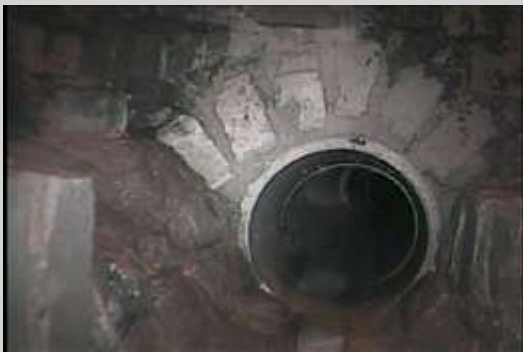
12 O'Clock Outflow

8 in. Circular Gravity Sewer
Pipe Out @ 12 O'Clock

Pipe Height: **8.4** (in.) Rod and Bar (Angled)
Pipe Material: **Clay** ☐ Pipe Lined
Invert Depth: **9.47** (ft.) Flow Characteristics: **Slow**
Deposits: ☒ None ☐ Mud ☐ Sludge ☐ Debris ☐ Grease
Silt Depth: (in.) Deposits Extent:
Infiltration: **None** Pipe Seal Cond: **Sound**

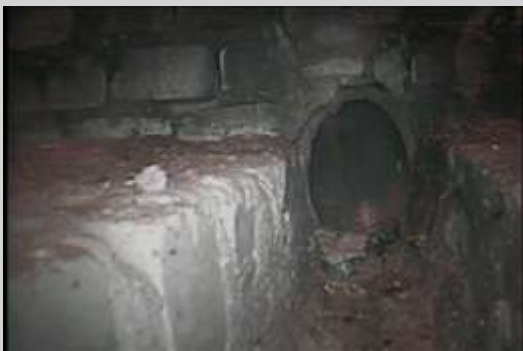
4 O'Clock Inflow

4 in. Circular Gravity Sewer
Pipe In @ 4 O'Clock

Pipe Height: **4.8** (in.) Rod and Bar (Angled)
Pipe Material: **Clay** ☐ Pipe Lined
Invert Depth: **9.14** (ft.) Flow Characteristics: **None**
Deposits: ☒ None ☐ Mud ☐ Sludge ☐ Debris ☐ Grease
Silt Depth: (in.) Deposits Extent:
Infiltration: **None** Pipe Seal Cond: **Sound**

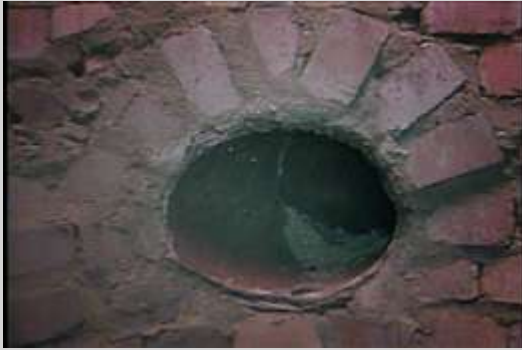
6 O'Clock Inflow

8 in. Circular Gravity Sewer

Pipe In @ 6 O'Clock

Pipe Height: **8.4** (in.) Rod and Bar (Angled)

Infiltration: **None** Pipe Seal Cond: **Sound**

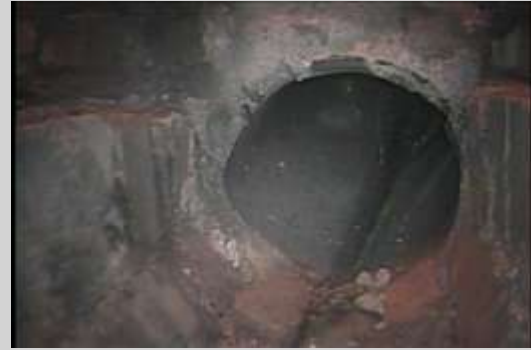
Drop In @ 6 O'Clock

Drop Condition: **Open**
